## Shed Extensions Progress Report - 29 January 2018

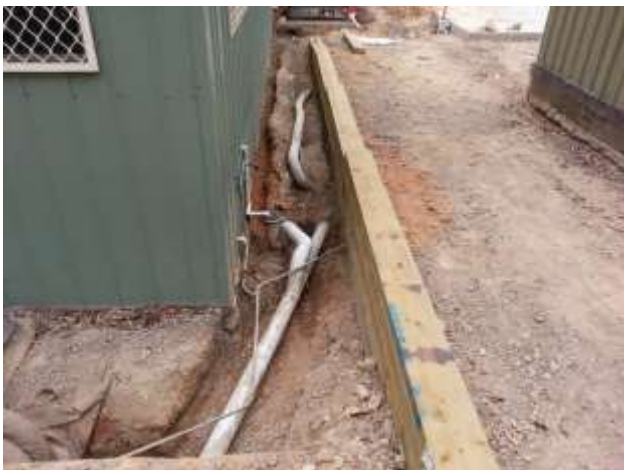
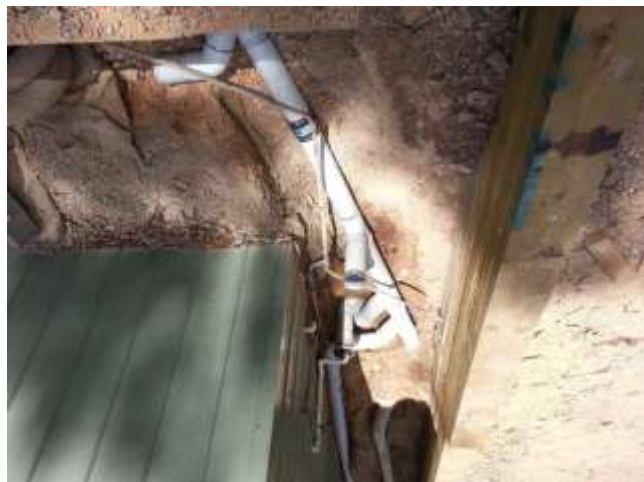
This before photo shows the pipe too high outside the lunch room. After - can you see the differences?

We now have our water supply system and waste water lines in place. The sewerage connection has been lowered to allow us to lower the ground level outside our lunch room where flooding of the above floor level ground caused water ingress into the lunch room and wet the carpet and floor. This also caused corrosion of the bottom of the metal cladding.

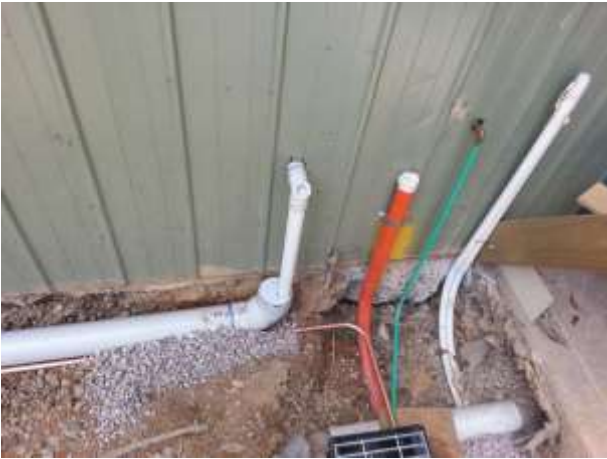
New outlet for metalwork sink gravity drainage

Our replaced sewer line also has a junction to allow for any future development west of the lunch room, e.g. an office, and we now have gravity drainage from the existing metalwork sink. Ultimately, we will be able to remove the pump-out system, hopefully before it gives trouble.

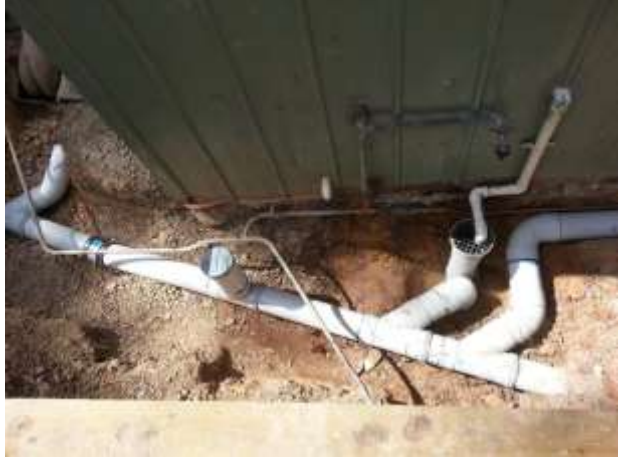
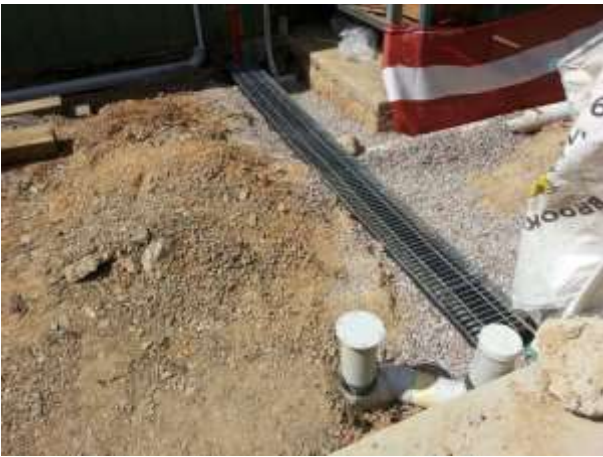
Channel drains installed with new sink connections for extension sink in foreground

Bryan and I completed the connection of the channel drains and Mark did a great job filling around and under them to get a suitable fall. I also finished the connecting brackets for the NE pit drain and will complete its installation on a sand/cement pad tomorrow (weather permitting). The drainage pipes can then be fully installed with bio fabric and gravel infill over the top.
